The Fire Resistance Performance Of Six Specimens Of Electrical Sockets And Sealing Systems, Utilising The General Principles Of BS EN 1364-1: 1999 In Conjunction With Additional Guidelines From BS EN 1366-3: 2004

182824

Fischer Fixings UK Ltd

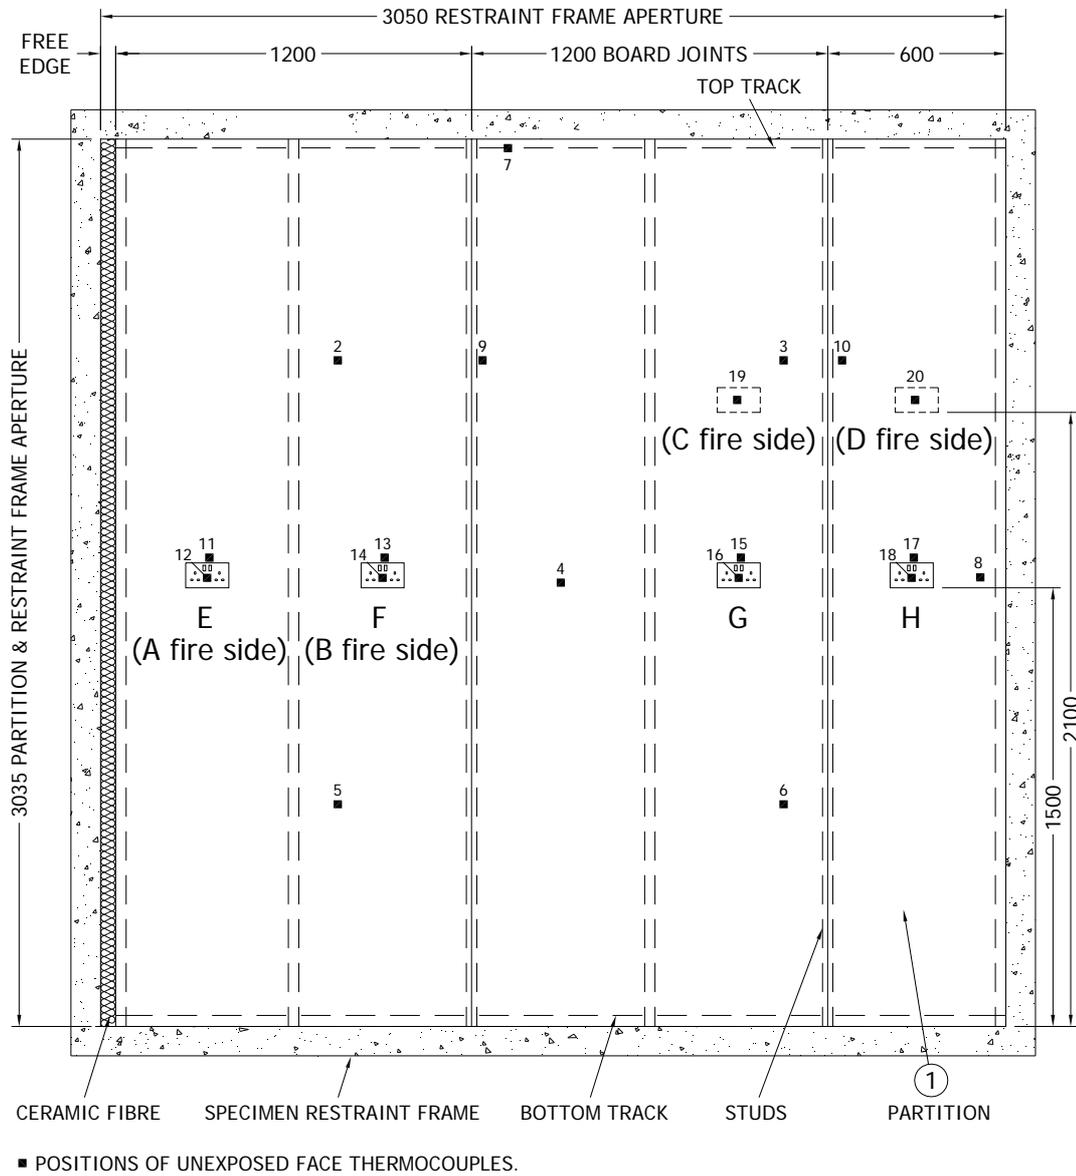
Figure 1- General elevation of the unexposed face of the partition and electrical sockets

The assembly comprised a drywall construction of overall dimensions 3050 mm wide by 3035 mm high by 100 mm thick, constructed utilising the material specification given in BS EN 1366-3: 2004. The wall incorporated six specimens comprising a range of electrical sockets. Further details are provided in the Test Specimen, Figures 1 to 3.

(Refer to Figures 1 to 3)
 (All values are nominal unless stated otherwise)
 (All other details are as stated by the sponsor)

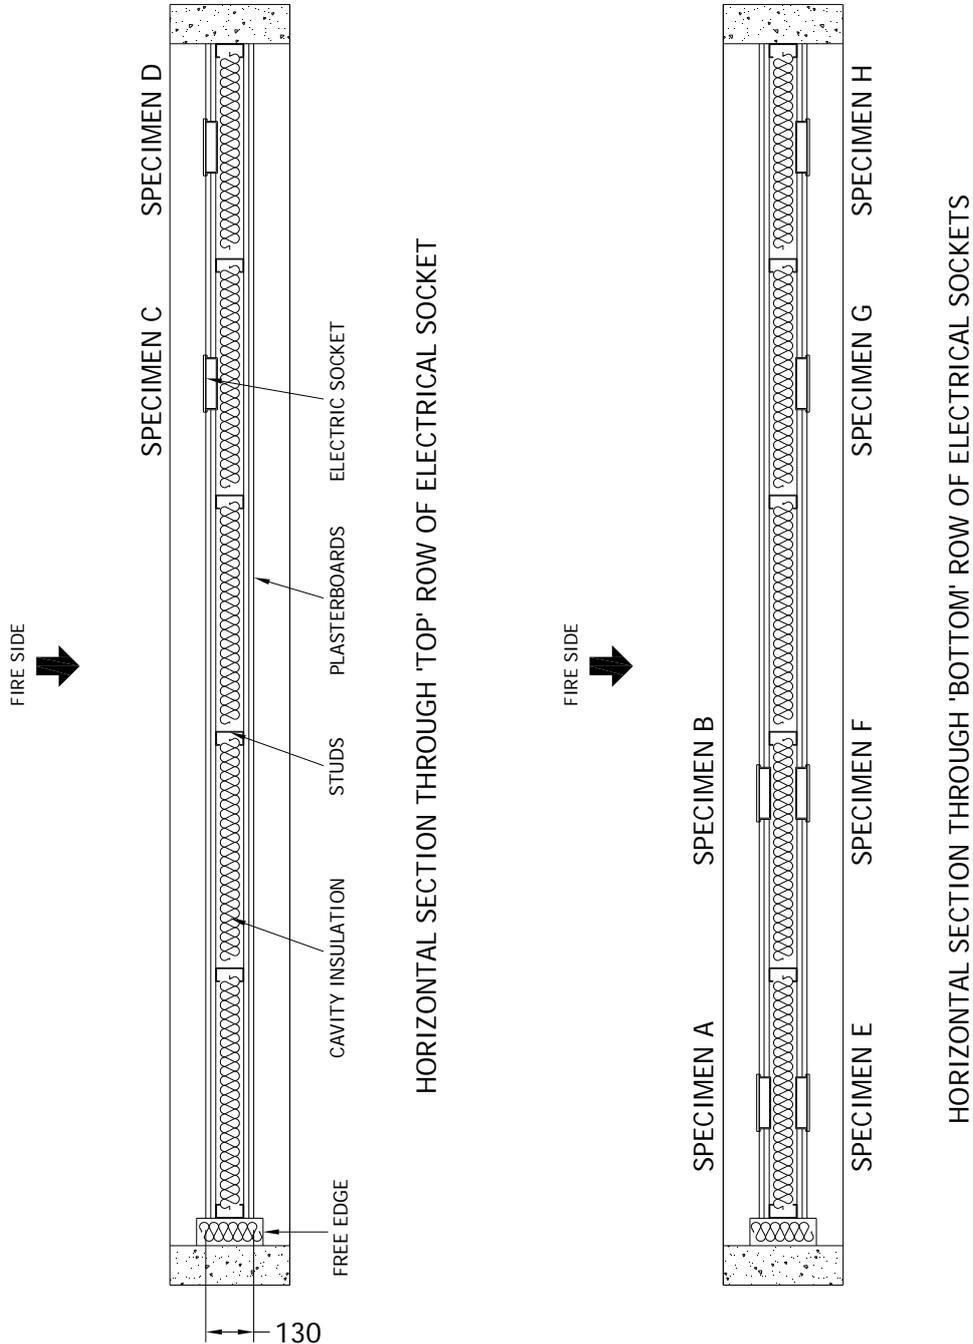
Figure 2 – Horizontal sections through the partition showing the electrical socket positions

- Type : Back box - standard dry lining electrical box, 13 A, 2 gang.
Cover plate - switched moulded socket outlet to BS 1363
- Material : Polyvinyl chloride (PVC)
- Overall sizes
 - i. back box : 132 mm x 73 mm
 - ii. cover plate : 145 mm x 85 mm
- Fixing : The back boxes were fitted into apertures cut into the plasterboards and fixed with two steel screws. The apertures were central between the studs and at a minimum distance of 250 mm from the perimeter edges of the partition. The cover plates were fixed with steel screws onto the back boxes
- Positions : Specimen A was fitted opposite to Specimen E
Specimen B was fitted opposite to Specimen F
Specimen C was fitted staggered to Specimen G
Specimen D was fitted staggered to Specimen H

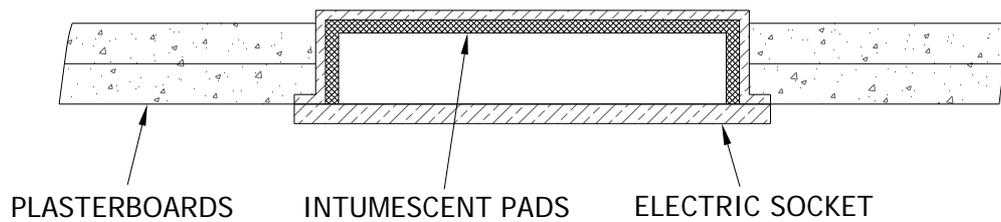
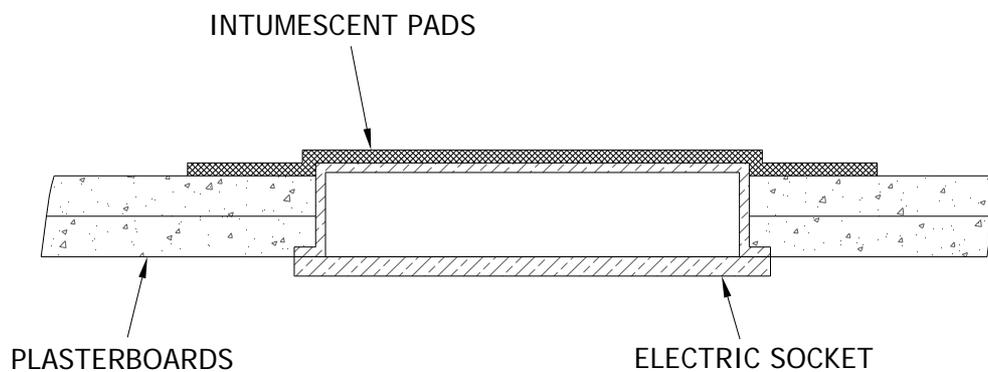
Figure 3 – Sections through the electrical sockets showing the positions of the putty pads

POSITION OF INTUMESCENT PADS
TO SPECIMENS : B, D, E, G

POSITION OF INTUMESCENT PADS
TO SPECIMENS : A, C, F, H

3. Putty pads 'new build' fitted onto the back face of the sockets – Unexposed face specimens F, H Exposed face specimens A, C

- Manufacturer : Fischer Fixings UK Ltd
- Reference : FiPP (Fischer intumescent Putty Pads)
- Material : Intumescent non-setting mouldable putty pads
- Sizes : 210 mm wide x 180 mm high x 3 mm thick
- Fixing : Fitted over the back box and overlapping the plasterboards during assembly of the partition
- Shape of pads : Rectangle

4. Putty pads 'retro' fitted into the sockets –

Manufacturer	:	Fischer Fixings UK Ltd
Reference	:	FiPP (Fischer intumescent Putty Pads)
Material	:	Intumescent non-setting mouldable putty pads
Sizes	:	230 mm wide x 170 mm high x 3 mm thick
Fixing	:	Inserted into the back boxes after they were fitted into the assembled partition
Shape of pads	:	Cross

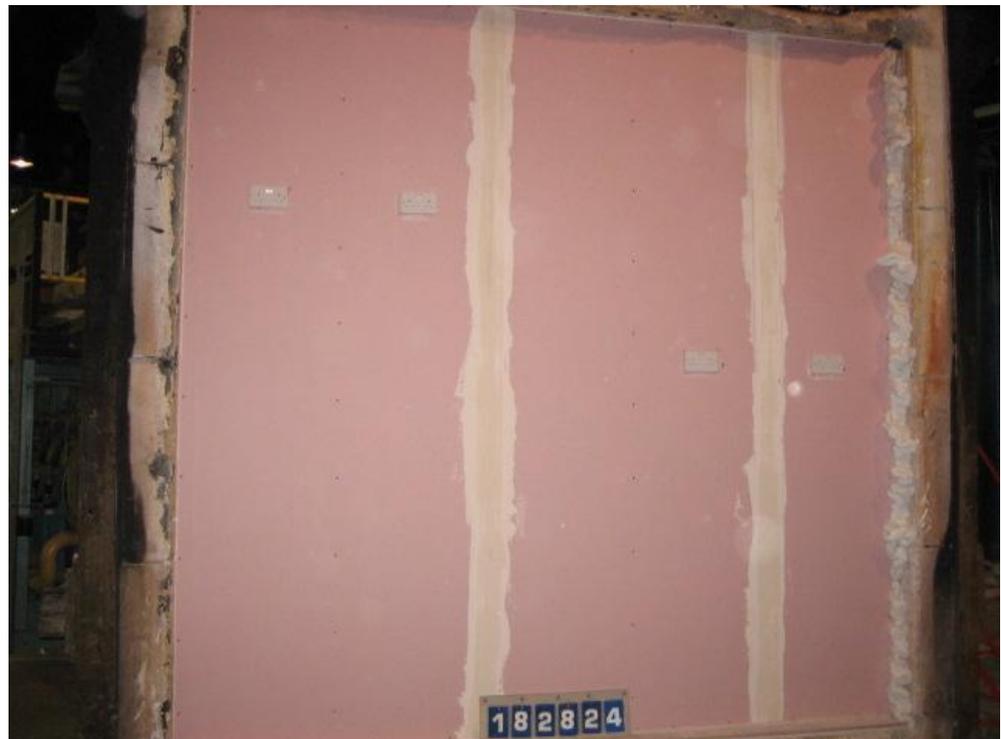
The exposed face of the specimens prior to testing

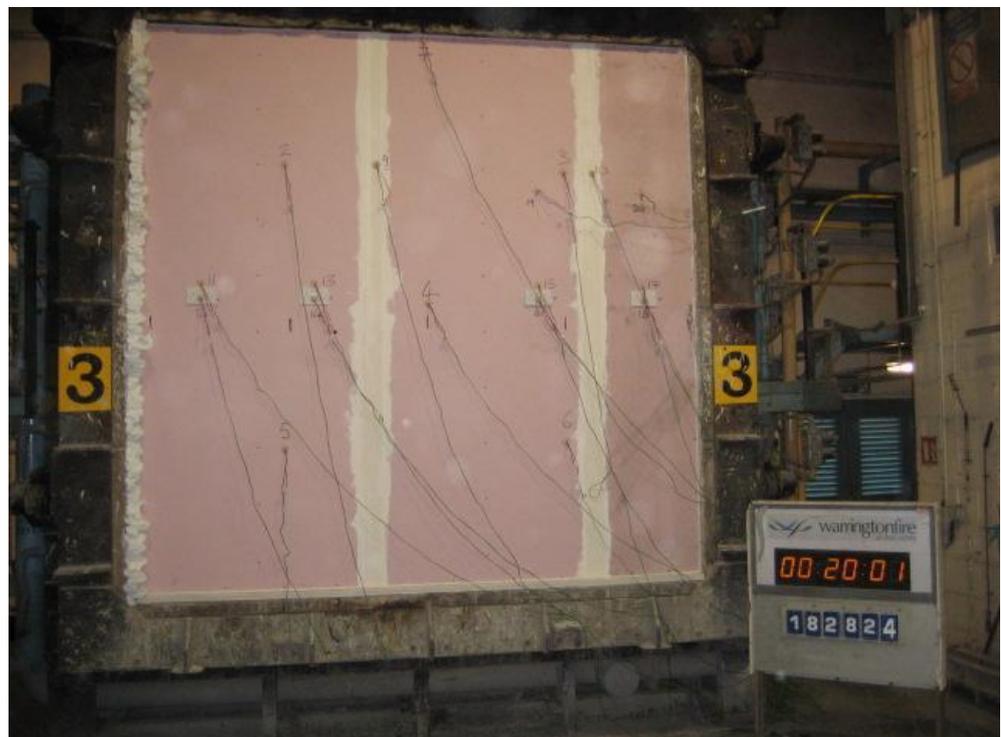
The unexposed face of the specimens after 20 minutes of testing

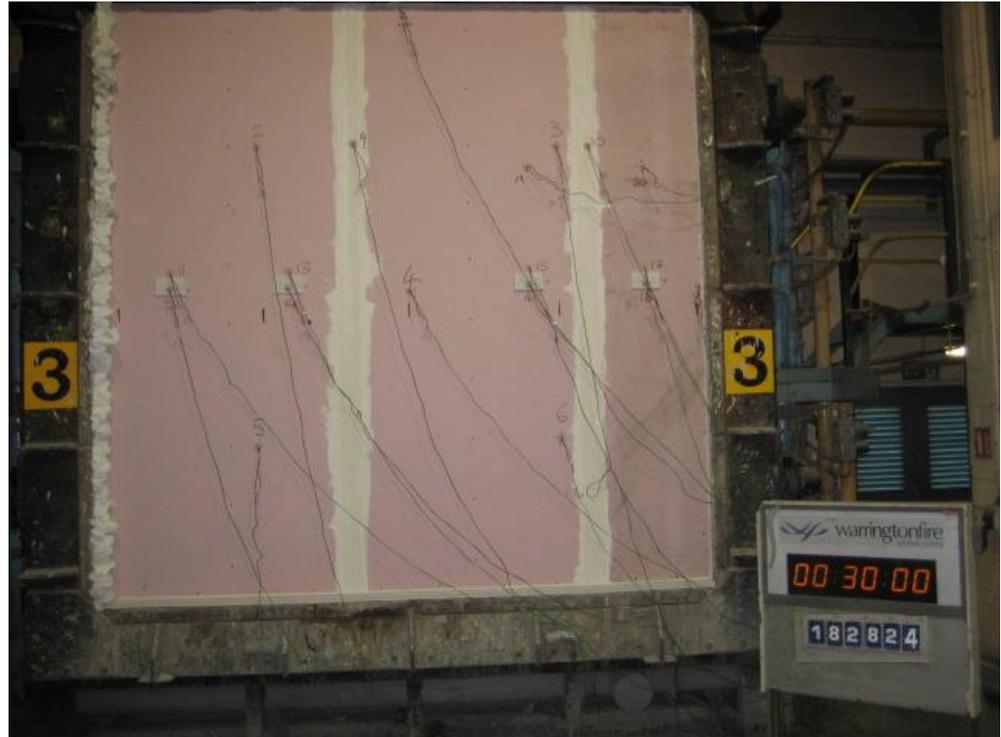
The unexposed face of the specimens after 30 minutes of the test

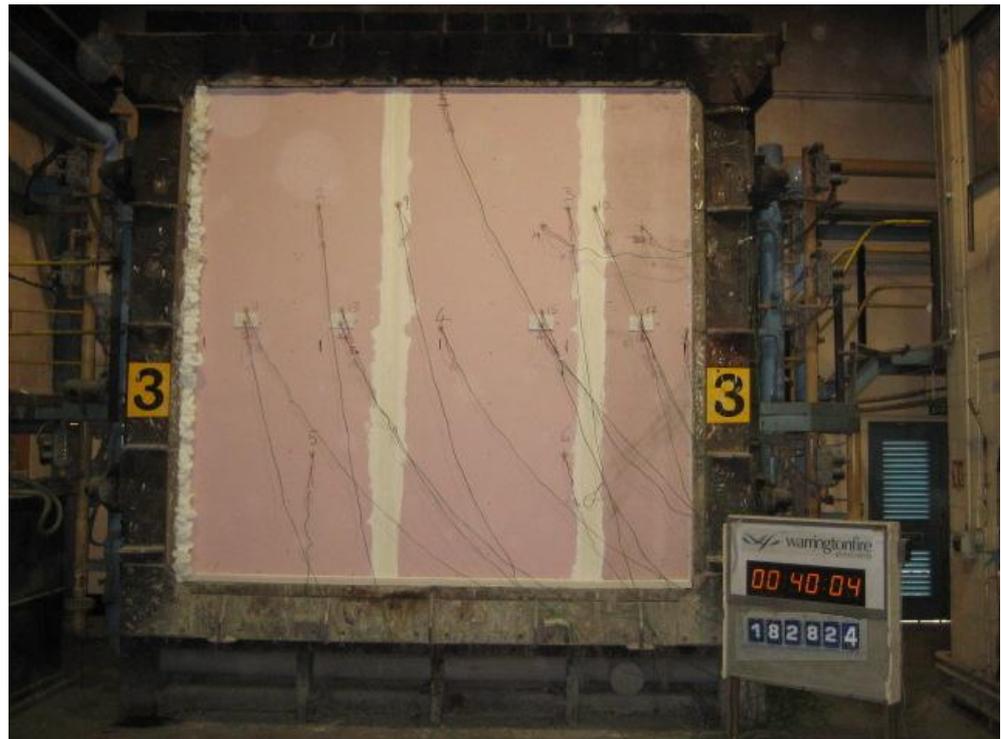
The unexposed face of the specimens after 40 minutes of the test

37	01	Viewed from the exposed side flaming is visible from specimens D and B.
40	00	Viewed from the exposed side, intumescent material is visible in the void of Specimen C, however there doesn't appear to be any material in the void of Specimen A.
43	00	The joints in the outer exposed plasterboard layer start to open up approx 10-20mm. The partition glows orange.
48	00	No significant visual change to the unexposed face.
51	00	Intumescent material has filled B & D but some dark voids are visible, flaming is visible from both sockets.
67	14	Flaming is still visible on the exposed face from specimens B and D; the outer layer of exposed plasterboard is still in place.
67	26	The partition starts to bow in across its horizontal axis at mid height. Steam/smoke release is visible at the head of the partition just to the left of mid-span.
72	30	The outer layer of exposed plasterboard starts to come away on its vertical joints where the board has shrunk past the screw fixings.

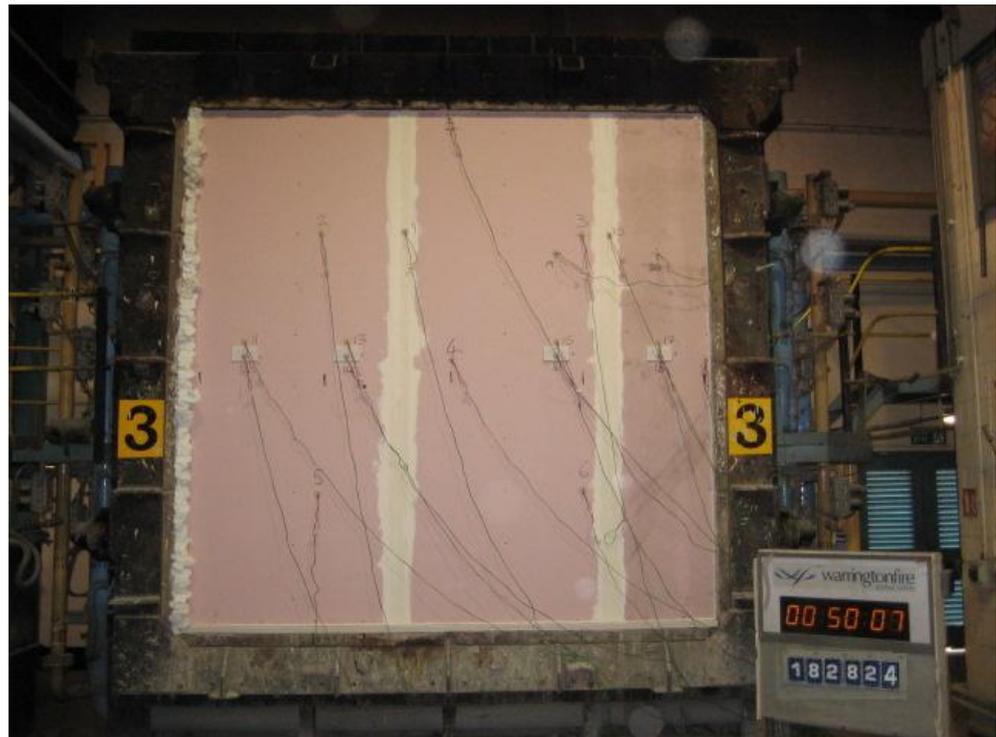
The unexposed face of the specimens after 50 minutes of the test

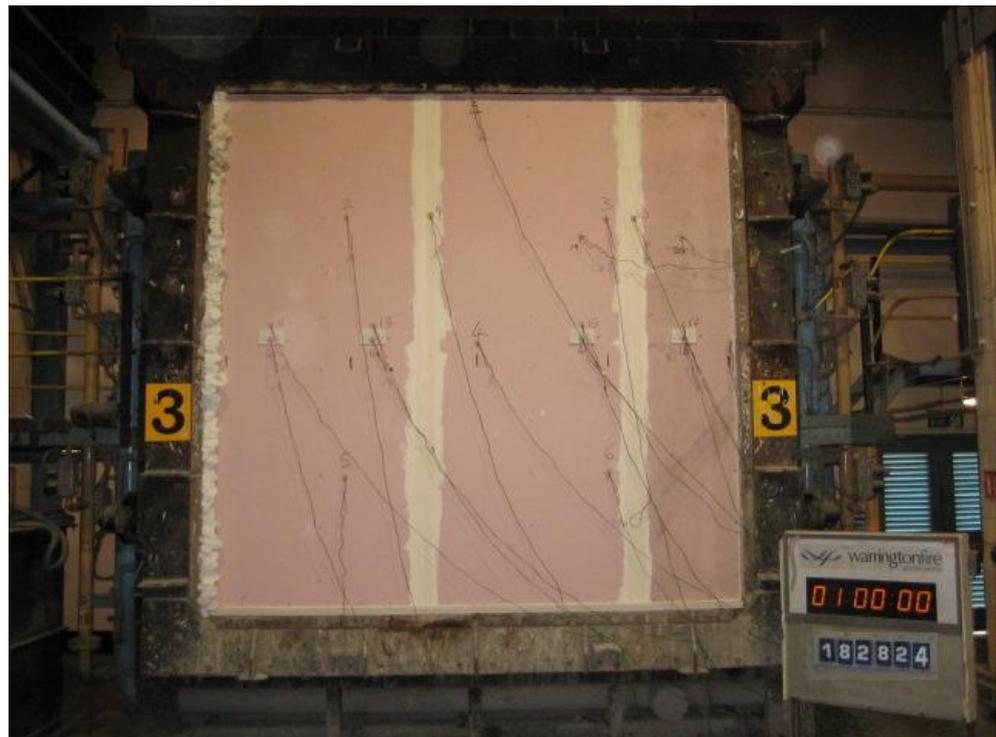
The unexposed face of the specimens after 60 minutes of the test

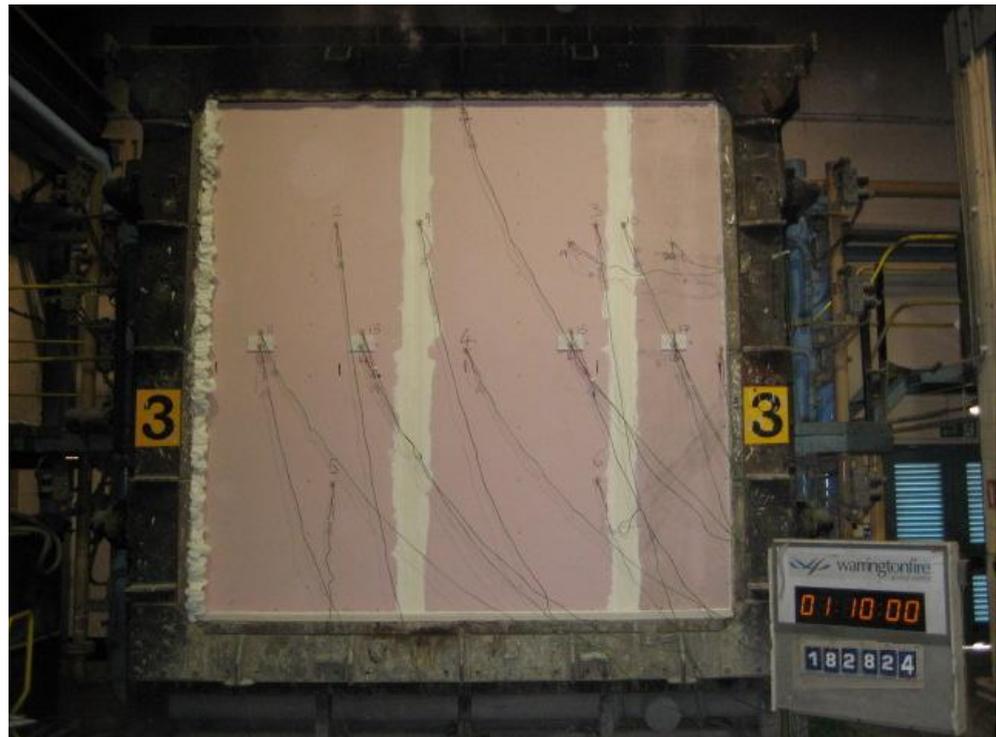
The unexposed face of the specimens after 70 minutes of the test

74	00	Flaming is visible on the exposed face from specimens A and C.

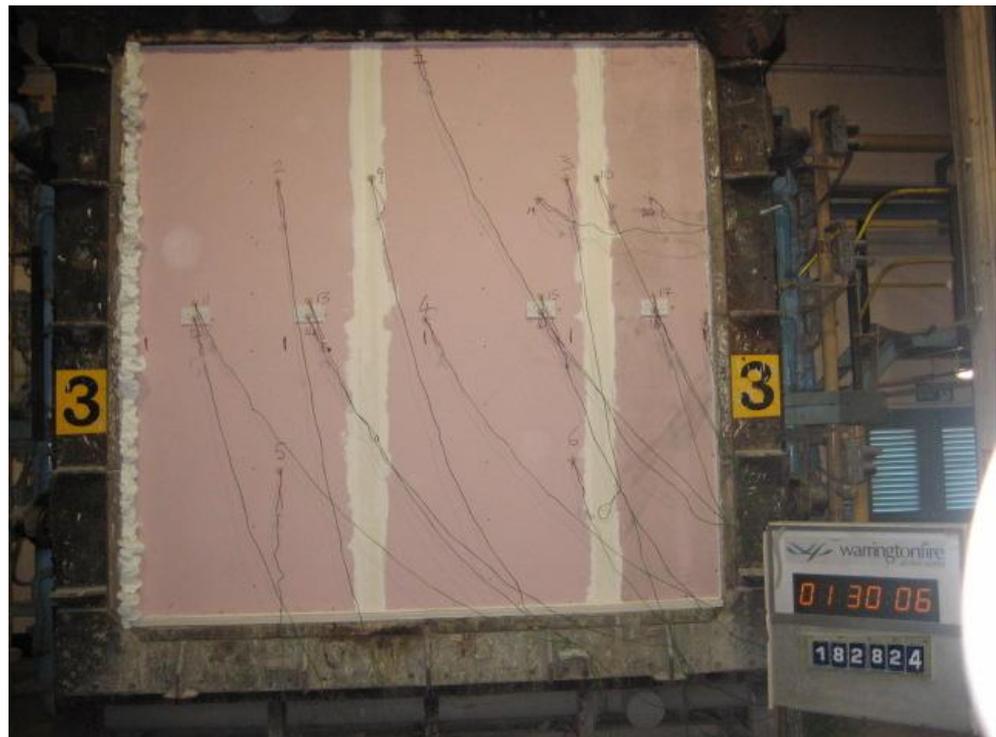
The unexposed face of the specimens after 90 minutes of the test

mins	secs	
80	00	The outer layer of exposed plasterboard is still in place, it's peeling open and bulging out as it starts to fall away.
91	00	The outer layer of exposed plasterboard has fallen away on the right hand side; some sections still remain attached on the left hand side. On the right hand side the rock wool core is also visible where the inner layer of plasterboard has also come away in places.
94	00	Moisture runs from the bottom right hand corner of Specimen F.
96	31	Viewed from the exposed side, both layer of plasterboard have fallen away at the centre of the partition, the rock wool cone is visible. Plasterboard remains attached on the left hand side and at the right hand perimeter.
100	00	Slight smoke release visible from the top edge of Specimen F.
103	00	The central section of exposed rockwool core falls away.
105	00	Smoke release starts to increase slightly from the top edge of Specimen F.

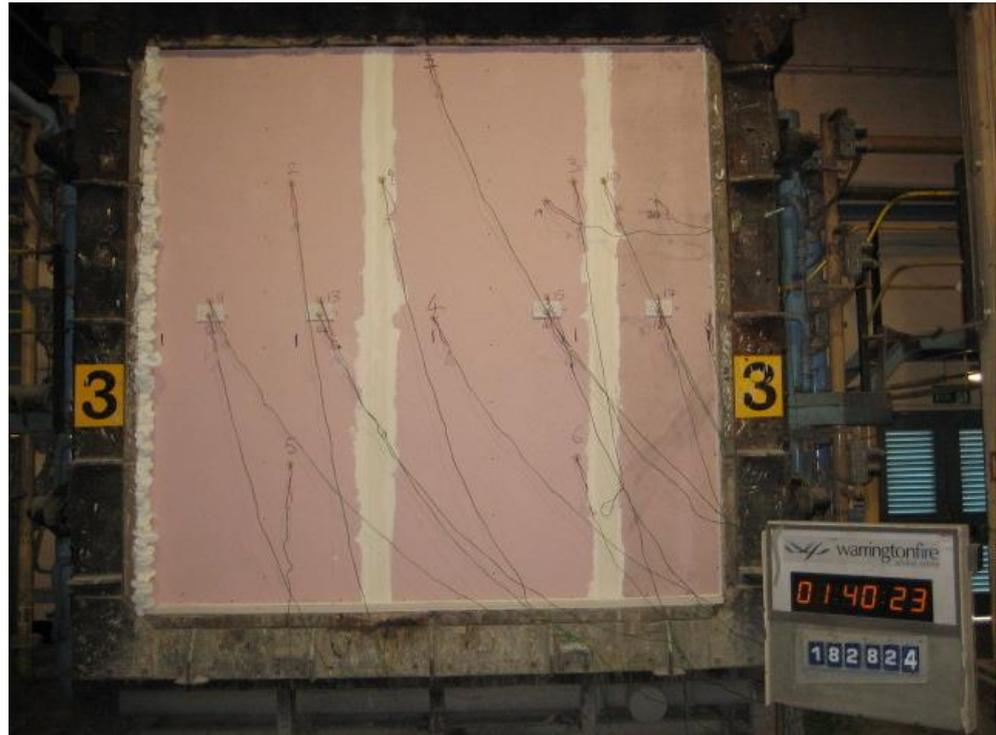
The unexposed face of the specimens after 100 minutes of the test

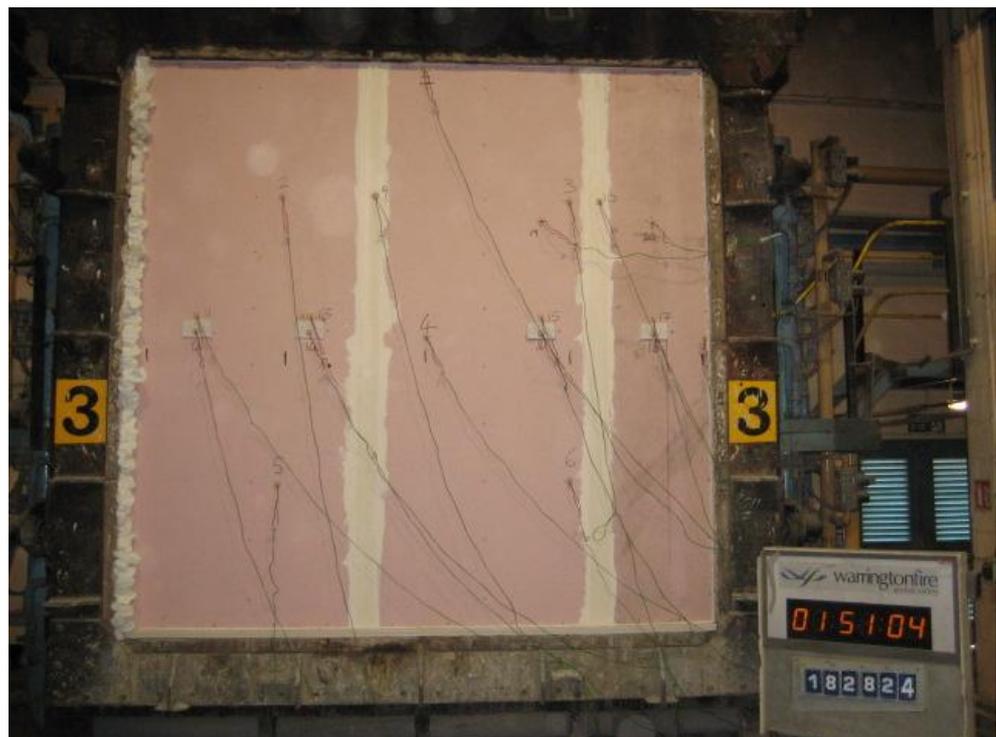
The unexposed face of the specimens after 111 minutes of the test

112	00	The top edge of socket cover on Specimen F is slumping away from the plasterboard very slightly.
113	00	Slight smoke release now also visible from Specimen H.
119	30	A cotton pad is applied to Specimen F where smoke release has increases over the top edge; the cotton pad fails to ignite.
120	00	The assembly continues to satisfy the test criteria.
123	11	A gap is now visible at the top edge of Specimen F where the socket cover has slumped forward; the plasterboard discolours around the top half of the socket.
126	06	A cotton pad is applied to Specimen F over the top edge; the cotton pad discolours but fails to ignite.
126	57	The test is discontinued at the sponsors' request.

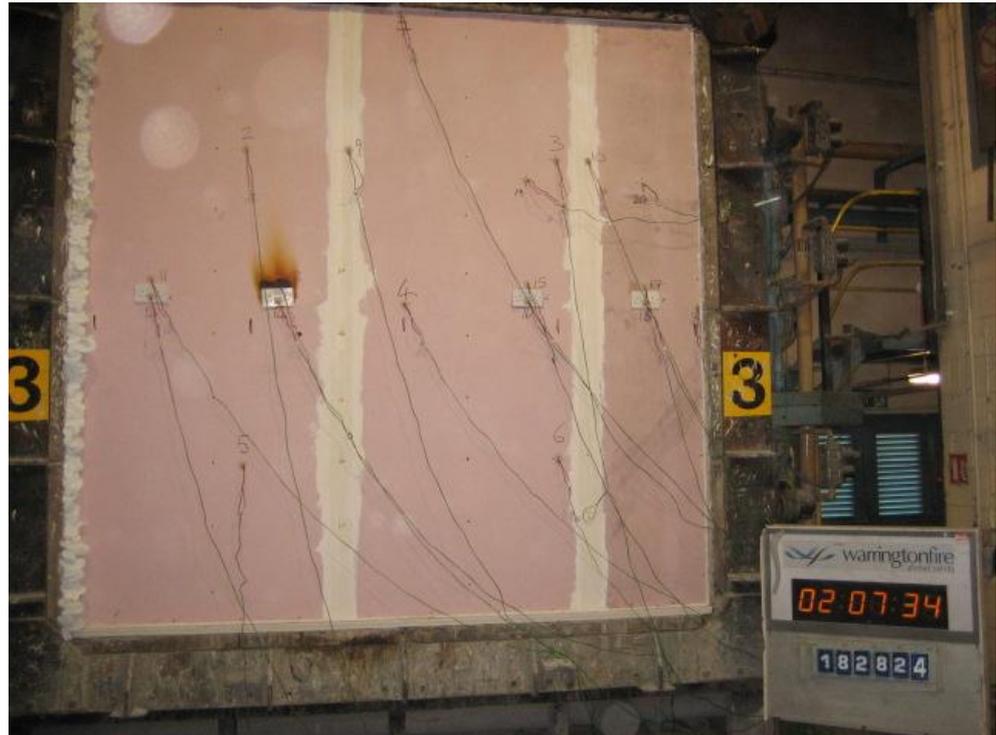
The unexposed face of the specimens after 127 minutes of the test

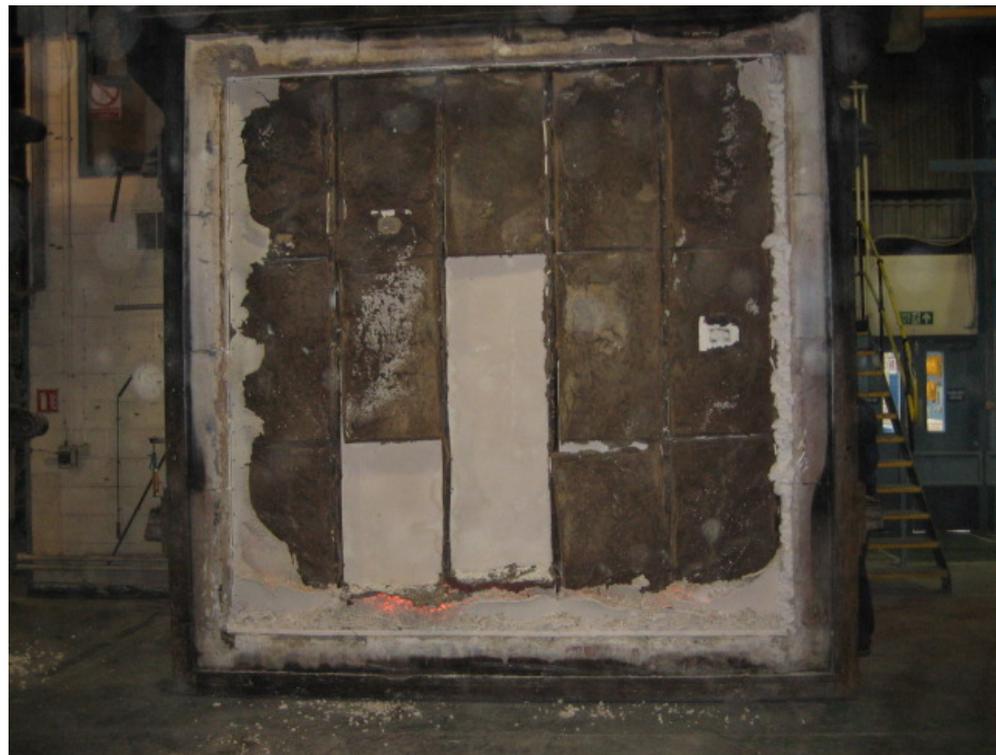
The exposed face of the specimens shortly after testing

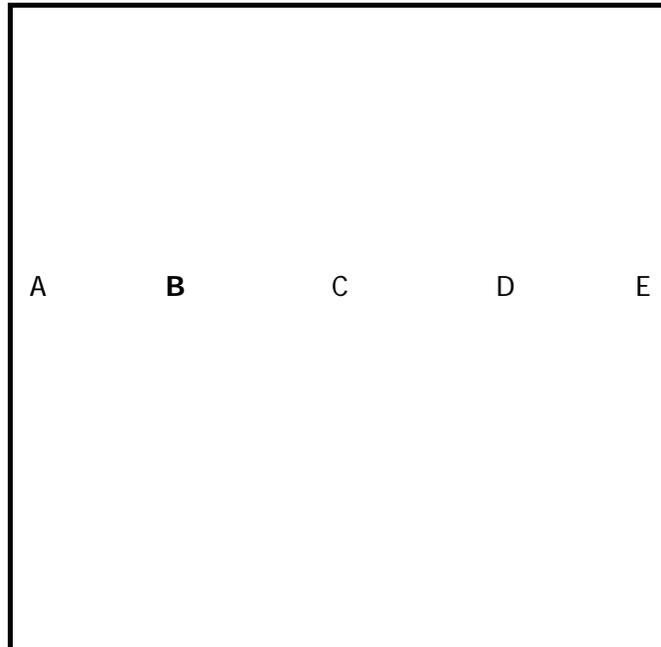
Recorded Deflections of the Partition during the test
Annex B (continued)

TIME mins	A	B	C	D	E
0	0	0	0	0	0
10	2	8	10	5	0
20	2	8	8	4	0
30	3	6	5	3	0
40	3	3	5	2	0
50	2	4	7	2	0
60	3	5	12	9	0
75	0	6	11	7	-1
90	2	8	13	6	-2
105	-2	0	10	5	-5
120	-7	-19	-10	-20	-15

Positive values indicate deflection towards the heating conditions

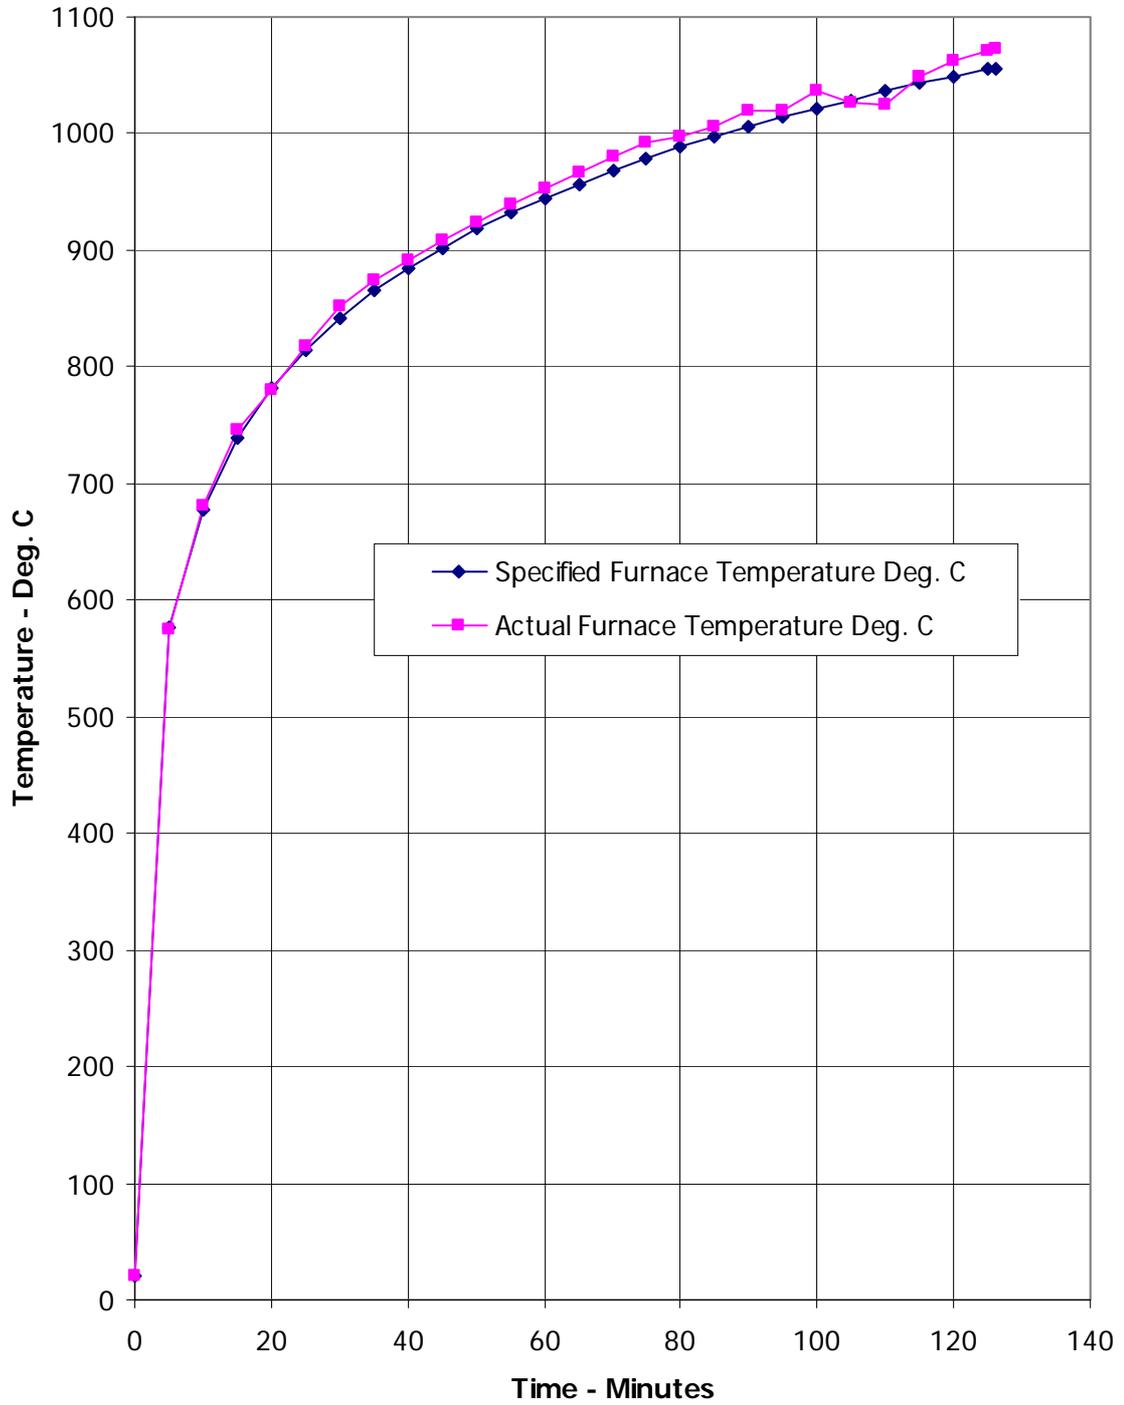
Graph Showing Mean Furnace Temperature, Together With The Temperature/Time Relationship Specified In The Standard

Time Mins	Specified Furnace Temperature Deg. C	Actual Furnace Temperature Deg. C
0	20	20
5	576	575
10	678	681
15	739	746
20	781	780
25	815	818
30	842	852
35	865	874
40	885	892
45	902	908
50	918	924
55	932	939
60	945	953
65	957	967
70	968	981
75	979	993
80	988	997
85	998	1006
90	1006	1020
95	1014	1019
100	1022	1037
105	1029	1027
110	1036	1024
115	1043	1048
120	1049	1063
125	1055	1071
126	1056	1072

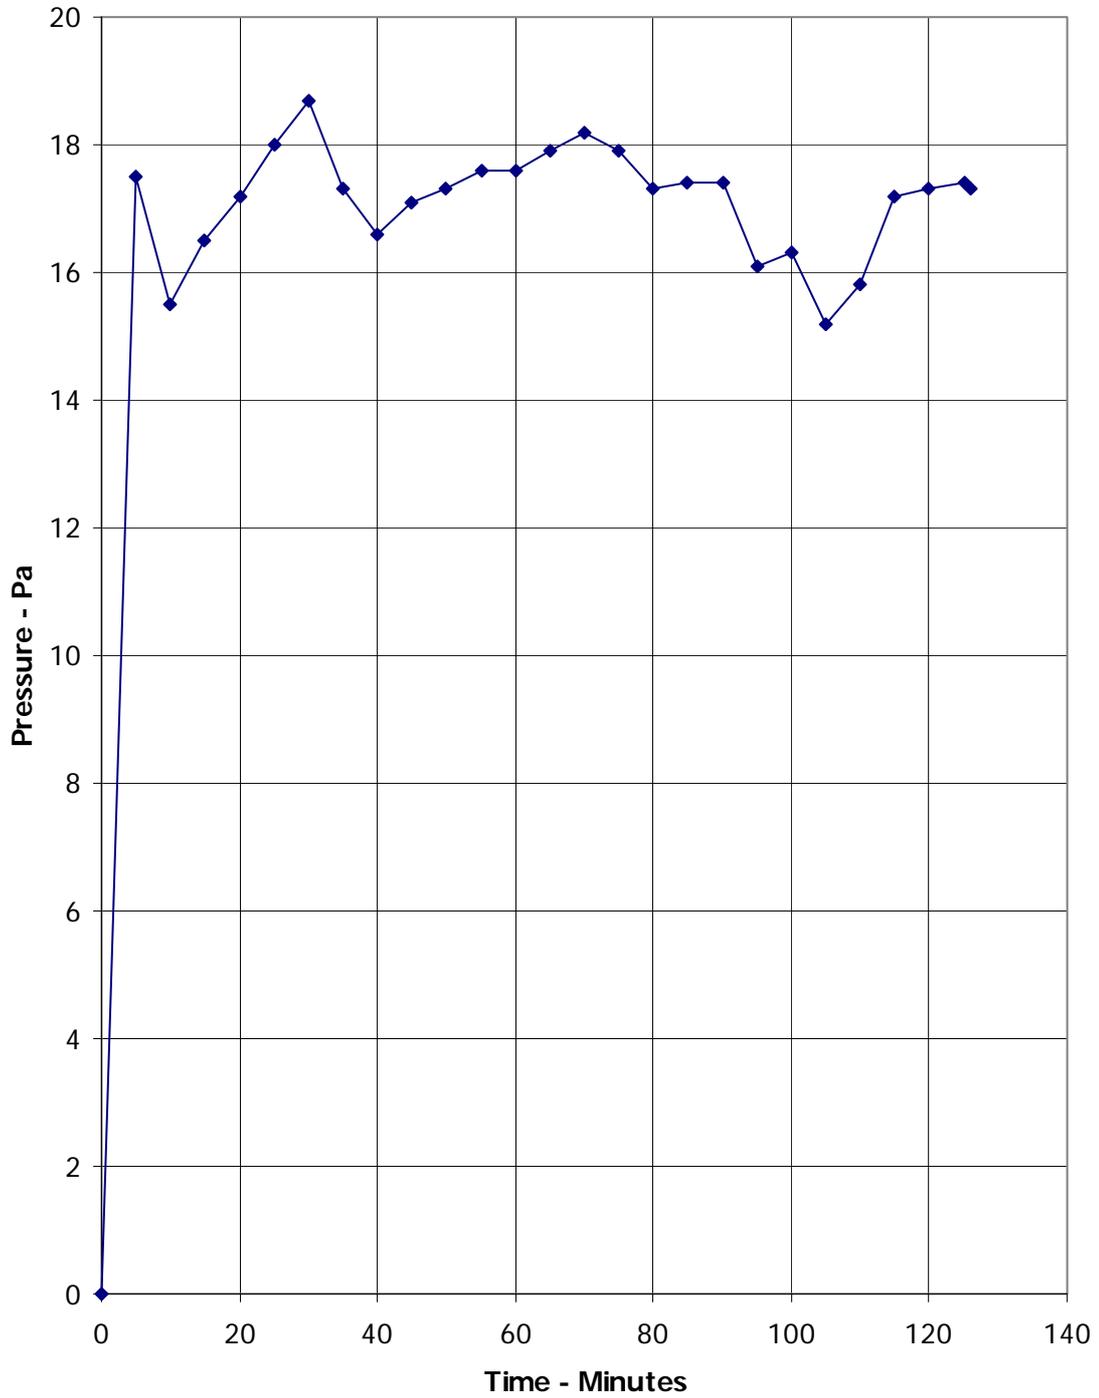
Graph Showing Recorded Furnace Pressure At 300 mm Below The Top Of The Partition Construction

Furnace Pressure	The furnace atmospheric pressure was controlled so that it complied with the requirements of BS EN 1363-1: 1999, Clause 5.2.
